Spacer Cable and Tree Wire Issues in Environments Containing Airborne Contaminants

Aerial Cable System Engineering Team,
Hendrix by Marmon Utility

Second Edition (Revised): May 13, 2026

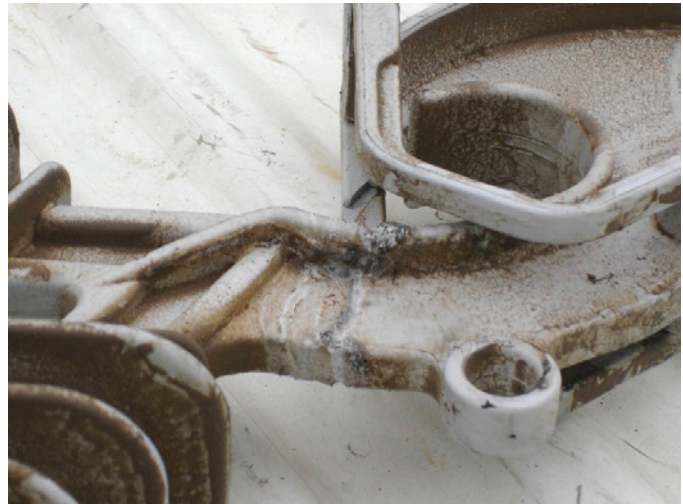
In general, all distribution systems will exhibit corona to some degree, depending on the voltage level, amount of contamination, presence of moisture, etc. This phenomenon is audible, and can be visible as well, depending on its severity and the amount of ambient light available. Without permanent contamination, however, the corona will mostly disappear when the system dries out. Permanent contamination, however, will also lead to tracking, which also makes an audible “buzz,” and which is much more likely to cause high temperature arcs and more serious and rapid damage, as demonstrated in **Photo 1**.

Photo 1: Silica Coated Spacer in Dry, Multiple-Contaminant Environment Exhibiting Dry Band Arcing Prior to Failure

A related phenomenon that is observed in extremely contaminated and insufficiently designed systems is Dry Band Arcing (DBA). This occurs when an accumulation of contaminants on the insulating surface reduces the surface resistance to a point where current begins to flow, which then eventually results in surface tracking along predetermined paths. It is possible to have a system suffer DBA and minor surface electrical erosion during an extremely prolonged dry season and not progress to a failure stage. Once significant damage has occurred, in terms of melting or pitting, the situation is usually progressive. That is, even with surface washing, the buildup of contaminants will likely take a shorter time to track, melt, and reach failure during the next dry season.

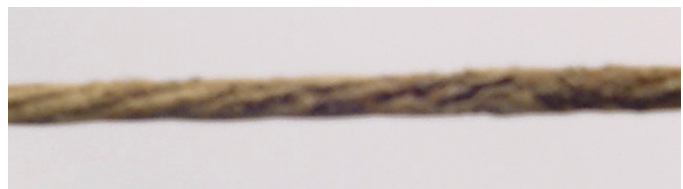
A phenomenon related to premature failures of spacer cable systems but unrelated to the covered conductor relates to the selection of messenger. Alumoweld or Alumoweld-Aluminum messenger was selected for its combined properties of high strength, ampacity (use as a system neutral as well as lightning shield), and corrosion resistance. The use of galvanized wire invites corrosion, loss of strength, and premature failure due to inability to support the system either mechanically or withstand the electrical damage from a lightning strike.

Photo 2: Galvanized Messenger in Dry Pacific Seacoast Environment after Only 9 Months

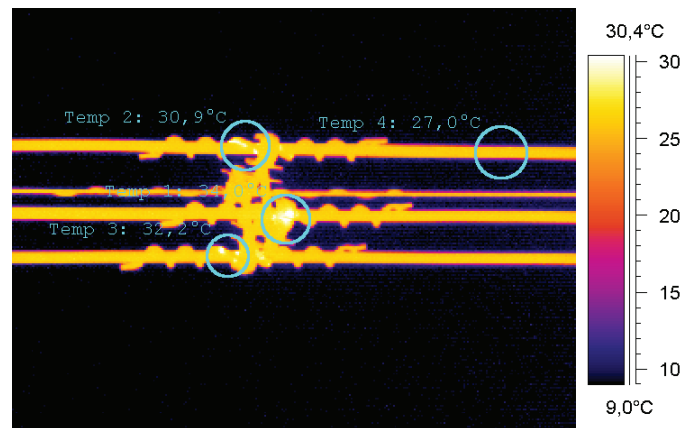
The line in question here is 15kV class built with 15kV components. Contamination Class is assumed between light and medium, according to IEC 815. To the right is shown a thermographic photo of temperature elevations on a mid-span spacer assembly. The temperature rise is due to the use of substandard components. The cable covering is of insufficient thickness. Suffice it to say, this is NOT a Hendrix system. What is interesting, however, is that the preformed ties used for connecting the spacer to the phase conductors, rather than being track resistant, are collection points for attracting tracking current to the spacer and towards the ground via the messenger.

Photo 3: Thermographic Photo of Temperature Elevations on a Mid-Span Spacer Assembly
